Manhole Inspection Summary

Manhole # S33A1_005MH

Location Address: **250 w dickman st**

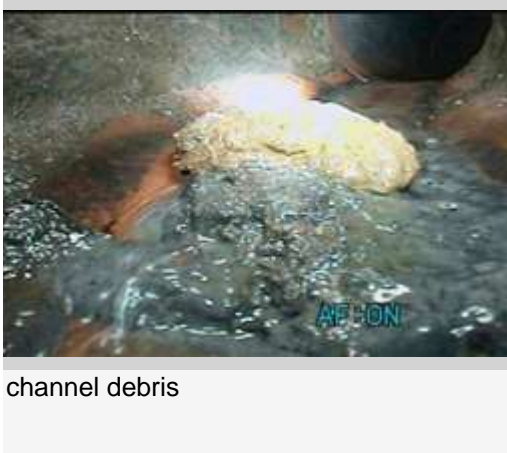
Misc

channel debris

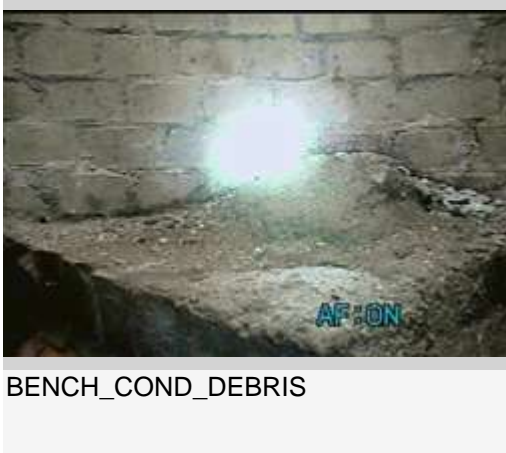
Defect 5

Condition: ☐ Sound ☐ Cracked ☐ Root Intrusion ☐ Deteriorated ☐ Leaks ☒ **Debris**

BENCH_COND_DEBRIS

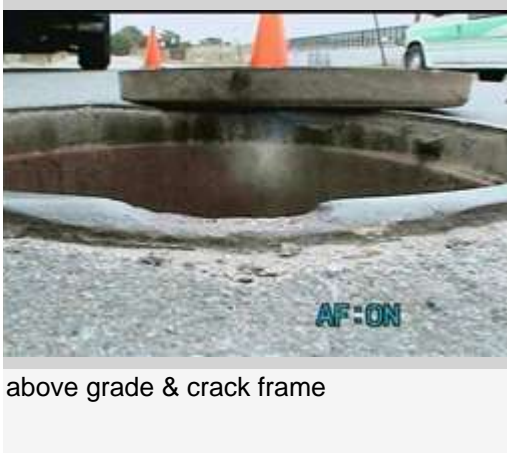
Defect 4

Condition: ☐ Sound ☒ **Cracked** ☐ Leaks

above grade & crack frame

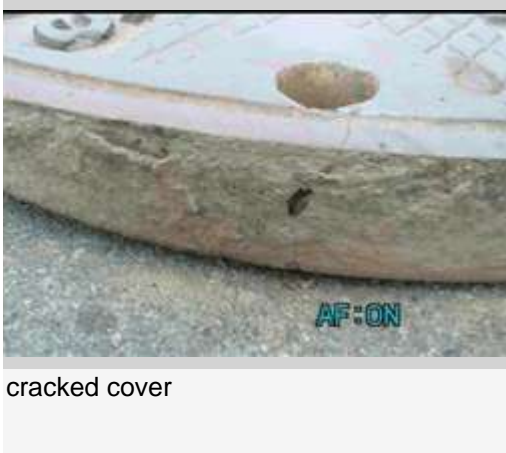
Defect 3

Condition: **Cracked**

cracked cover

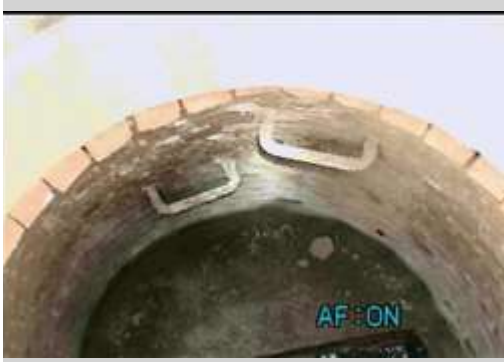
Defect 2

Count: **2** Missing: **0** ☒ **Corroded**

steps

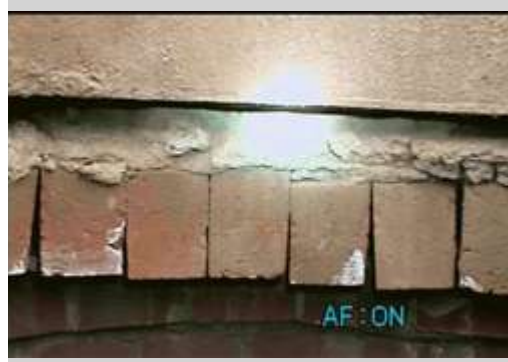
Defect 1

Condition: ☐ Sound ☐ Cracked ☐ Root Intrusion ☒ **Loose Brick** ☐ Deteriorated

CHIMNEY_COND_LOOSE_BRICKS
